Test Report#: 0284
Issue Date: Monday, July 23, 2012

Subject:
Sample description: Solid Fuel Burning Insert Fire
Make/Model: Undisclosed

Standard Specification and Scope:
AS/NZS 2918:2001 Appendix B Thermal testing of installation clearances;
Appendix B sets out the method for determining the maximum temperature rise above ambient temperature of heat sensitive materials as specified installation clearances from a solid fuel burning appliance.

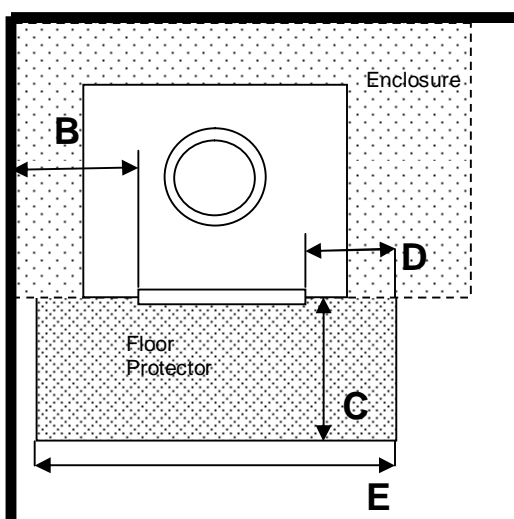
Test Results for high/Flash fire WITHOUT SmartBurn Additive:

Parallel Position Clearance Distance	Position	Clearance (mm)	Max temp rise	
			High	Flash

A	N/A	Rear Wall	
			2.11	1.95
	B	320	Side Wall	
			56.48	49.74
	C	300	Floor	
			43.68	32.96
	D	200	Ceiling	
			34.25	32.12
	E	1309	Internal Cavity	
			33.3	36.1
Mantel	Nil	Mantel		
		Nil	Nil

1. The clearance measurement B were taken from the distance between walls and closest door edge of the appliance, C and D were measured from the edge of the floor protector to the door opening.
2. Fire as tested per installation had 375 mm clearance from the lower edge of the fire metal cabinet to the ground floor.

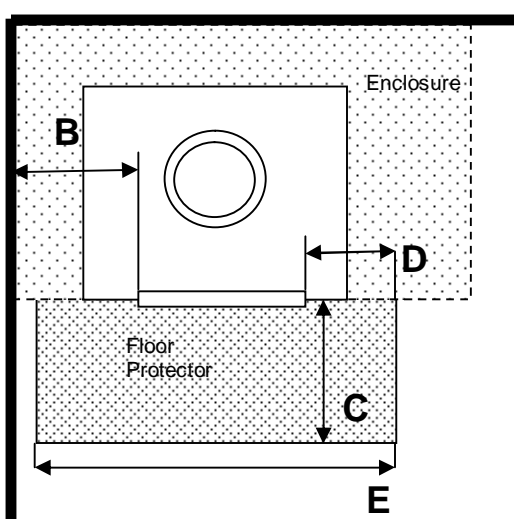
Test Results for high/Flash fire WITH SmartBurn Additive:

Parallel Position Clearance Distance	Position	Clearance (mm)	Max temp rise	
			High	Flash

A	N/A	Rear Wall	
			8.3	1.67
	B	320	Side Wall	
			56.40	50.06
	C	300	Floor	
			44.62	30.82
	D	200	Ceiling	
			36.42	40.19*
	E	1309	Internal Cavity	
			34.4	35.0
Mantel	Nil	Mantel		
		Nil	Nil

**Note that this is the greatest deviation between the two results, the flash fire is the most unpredictable aspect of the test and the deviation was still only approximately 8°C.*

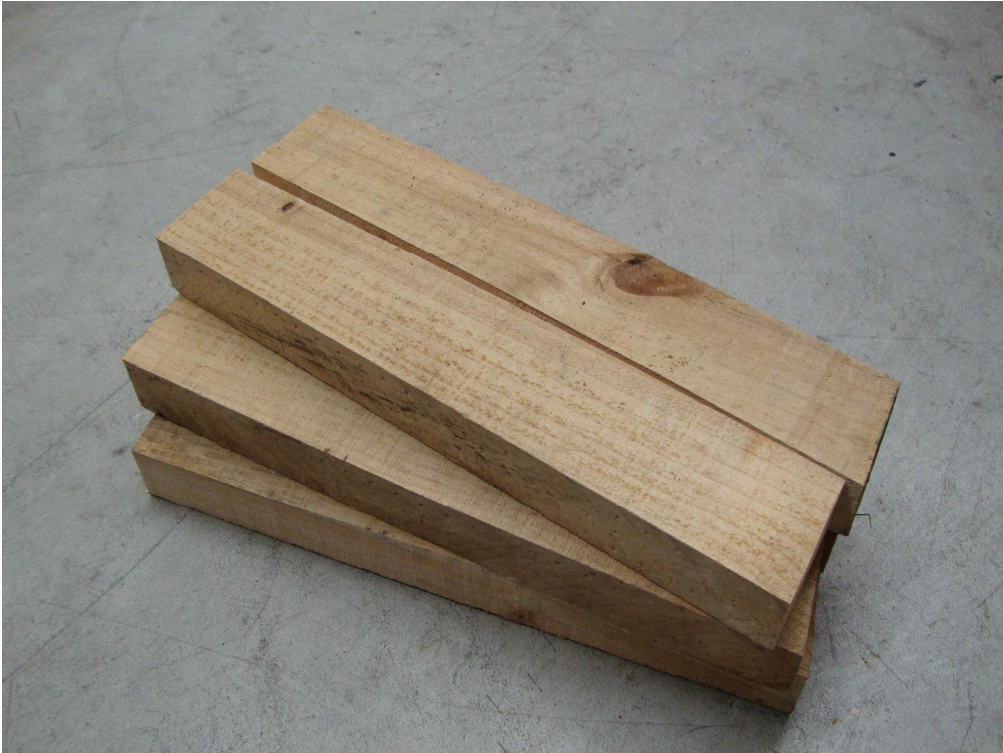
Photo 2: Flash fire test fuel load.

High fire test fuel pieces: 21
High fire total weight: 27.6 kg
Flash fire test fuel pieces: 6
Flash fire total weight: 7.446 kg
Test Fuel length: 505 mm
Moisture content range: 10 - 20%

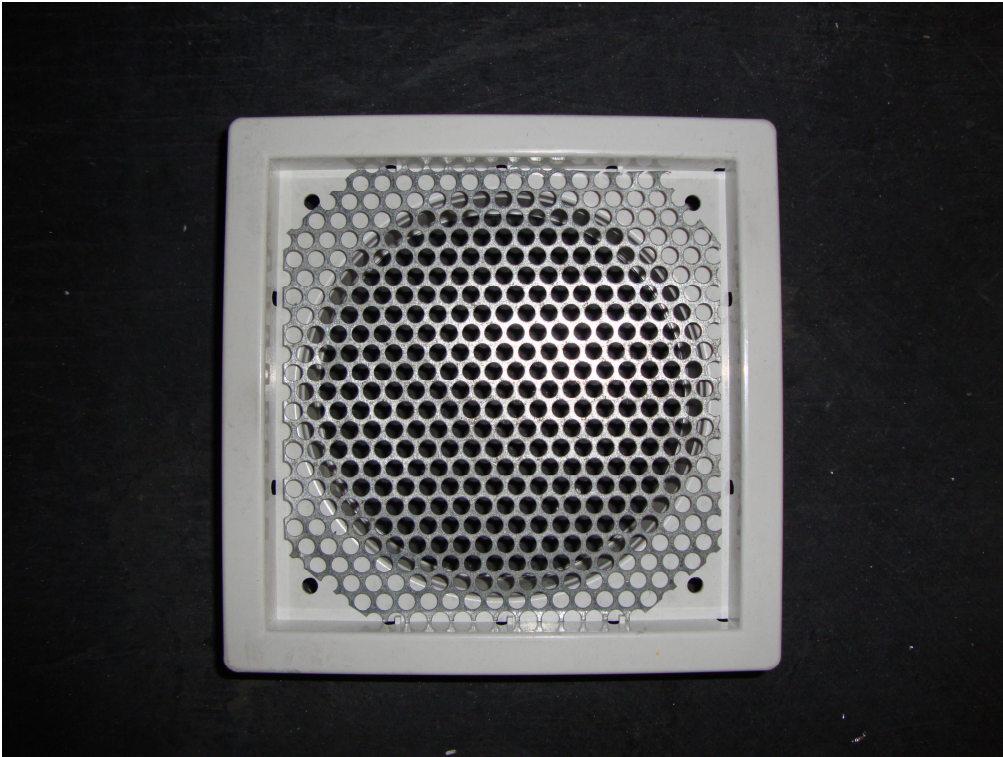
Photo 3: Air inlet brackets and mesh.

There were two circular air inlet with 100mm diameter located at the rear of the bottom hebel brick. Both air inlets were covered with metal mesh with 5mm holes.

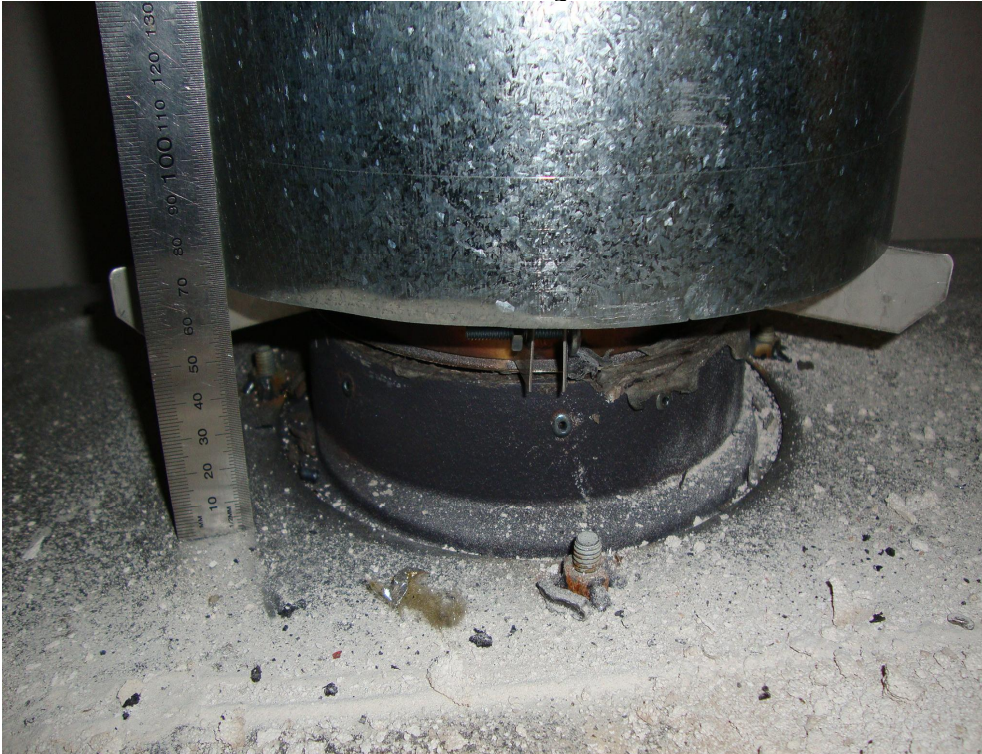
Photo 4: Air inlet for the clue system.

There was a 295mm x 400mm opening surrounding the flue system located at the top of the cavity. The opening was covered with metal mesh with 5mm holes.
